Microclimate Control in The Affandi Museum Gallery Yogyakarta

Bambang Pramono*
Danang Febriyantoko**

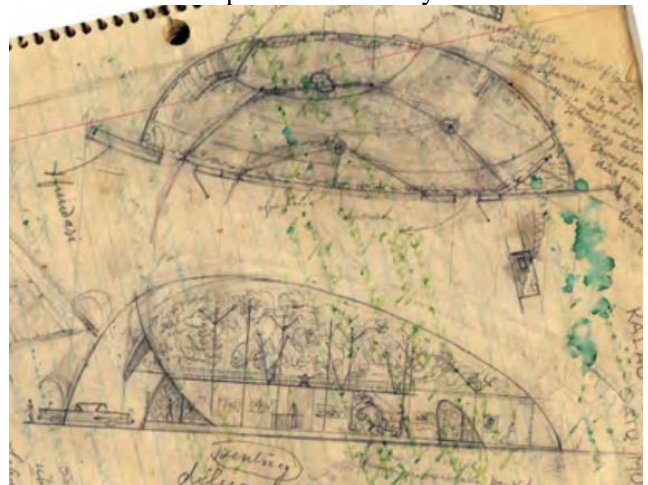
Fig. 1. Affandi's Sketch for 1st Gallery
Source : Affandi's Museum Collection

Affandi designed the museum complex around his residence, based on preliminary sketches that showed several galleries and a residence. Although not all of the buildings were ultimately designed by the artist, Affandi expressed many ideas in sketches and models that allow us to follow the process of evolution from his initial ideas to the museum complex we see today.

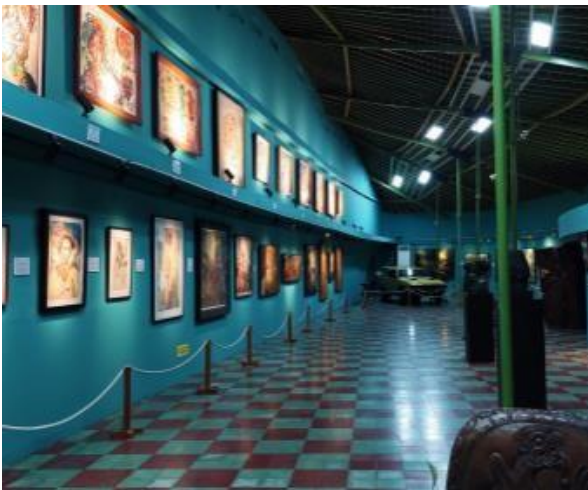
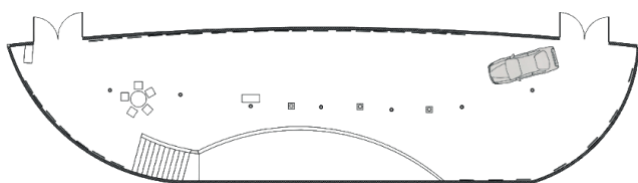
Fig. 2. Affandi's 1st Gallery Interior and Floor Plan
Source : Affandi's Museum Collection

With its unique shape and design, this building, designed by Affandi himself, utilizes natural light as the primary lighting source in its exhibition spaces. The design was inspired by banana leaf stems. The use of a skylight extending through the center of the roof allows natural light to enter the exhibition space. The sufficient lighting entering the gallery provides comfortable viewing for observers in appreciating the artwork. Conversely, from a conservation perspective, artworks

This gallery was built in 1962 in stages, completed and officially opened in 1974. This building can be accessed through 2 doors located at each end of the building, with a metal motif arched door shape. This gallery measures 314.6m² and contains Affandi's paintings on paper, canvas, watercolor, oil paint as well as personal belongings of Affandi. One of the striking exhibition media of this gallery is a replica of a statue depicting Affandi with his daughter Kartika and his favorite car Mitshubitshi Gallant 1976. This building has undergone several changes related to the conditional layout, considering the climatic conditions including temperature and humidity that have changed since it was first inaugurated. One of the most striking changes or technical engineering is on the roof of the banana leaf-shaped fin, initially light could directly enter through the skylight but now because it affects temperature and humidity, the skylight is then closed to reduce heat that can damage the collection. In addition, the air vents in the walls of the building are also closed to maintain the humidity of the room. Currently, gallery 1 uses more air conditioning and adjusts the lighting to maintain the temperature and humidity of the room.

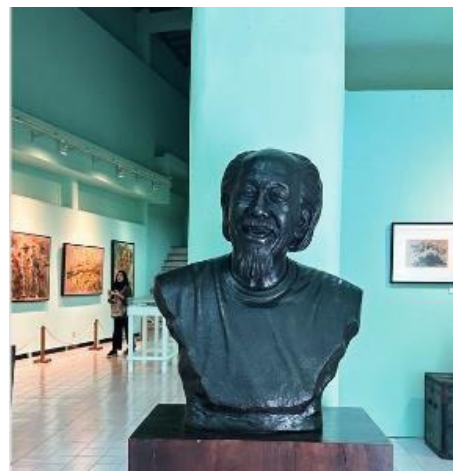
Fig. 3. Affandi's 2nd Gallery Interior and Floor Plan
Source : Affandi's Museum Collection

After receiving funding from the government, in 1988 the building was officially opened after a year of construction. Affandi's design and concept are still reflected in this building, similar to gallery 1 in the shape of a banana leaf stem. This building consists of 2 floors where the first floor functions as an exhibition space, and the upper floor functions as a painting storage space. The philosophy of this building reflects the historical value of Affandi's travels which are reflected in his paintings and the items he brought when visiting several countries in the world such as India, France, Brazil, and so on. This building has an area of 352.5 m² with a high ceiling and has modular walls and columns for exhibition purposes.

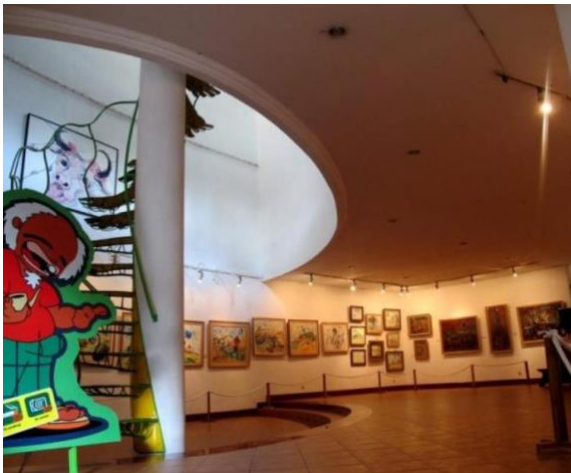
Fig. 3. Affandi's 3rd Gallery Interior and Floor Plan
Source : Affandi's Museum Collection

Gallery 3 was built due to the need for the preservation of artworks, therefore in this gallery there is a conservation room for practical needs related to workshops and restoration of works by Affandi, his family, and also friends. This building was built in 1999 and officially opened by the Governor of the Special Region of Yogyakarta, Sri Sultan Hamengkubuwono X in May 2000. The design and shape of this building is slightly different from the previous gallery, the most visible difference is the presence of two round towers that function as conservation and care rooms for the collection. One form that is still maintained from the previous gallery is the form of ventilation and also the design of the door that uses decorative ornaments made of metal.

This building consists of two floors, where the first floor displays the works of the Affandi family, such as the works of Maryati (Affandi's first wife), paintings of Kartika (Maryati's daughter), and paintings of Rukmini (Affandi's daughter from his second wife). The second floor is used as a restoration room and the basement as a warehouse. This building has an area of 147.6 m² and is directly adjacent to the Gajah Wong River.
